EXPLOSION AT EASINGTON COLLIERY COUNTY DURHAM

Report

On the causes of, and circumstances
attending, the explosion which occurred at
Easington Colliery, County Durham,
on the 29th May, 1951.

H.M. Chief Inspector of Mines

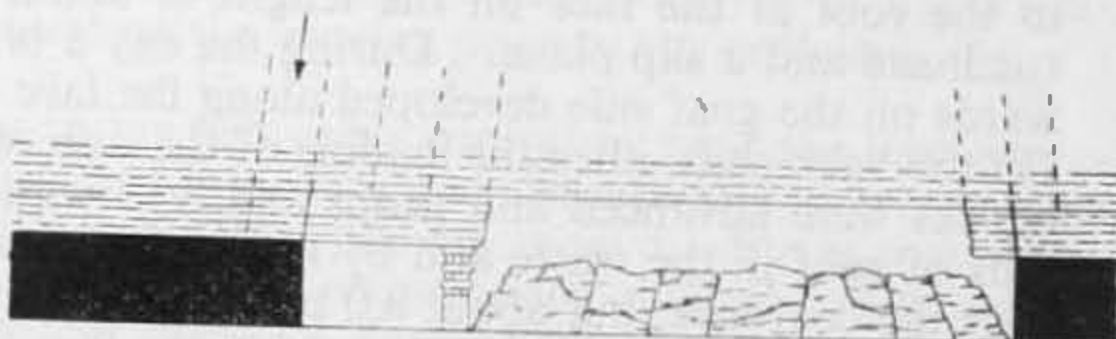
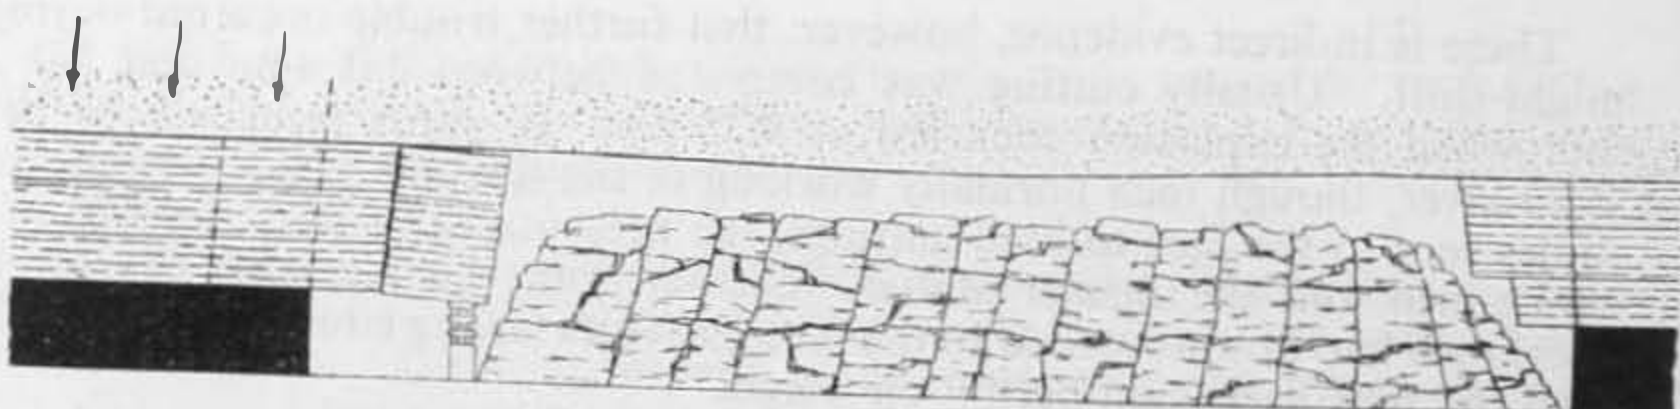
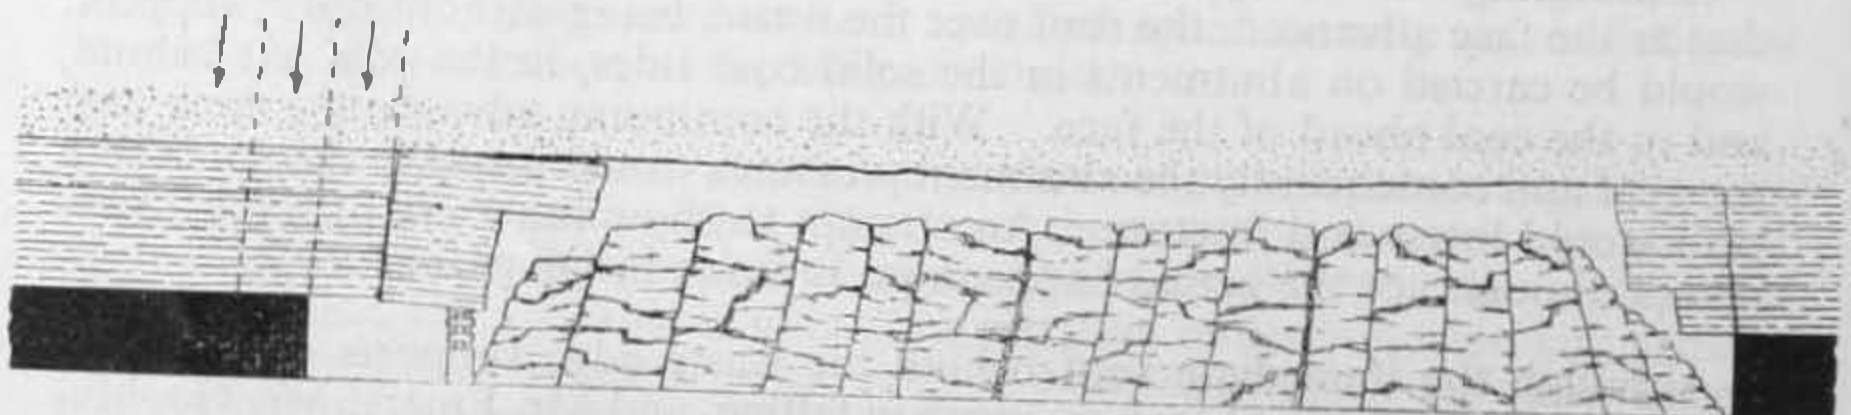
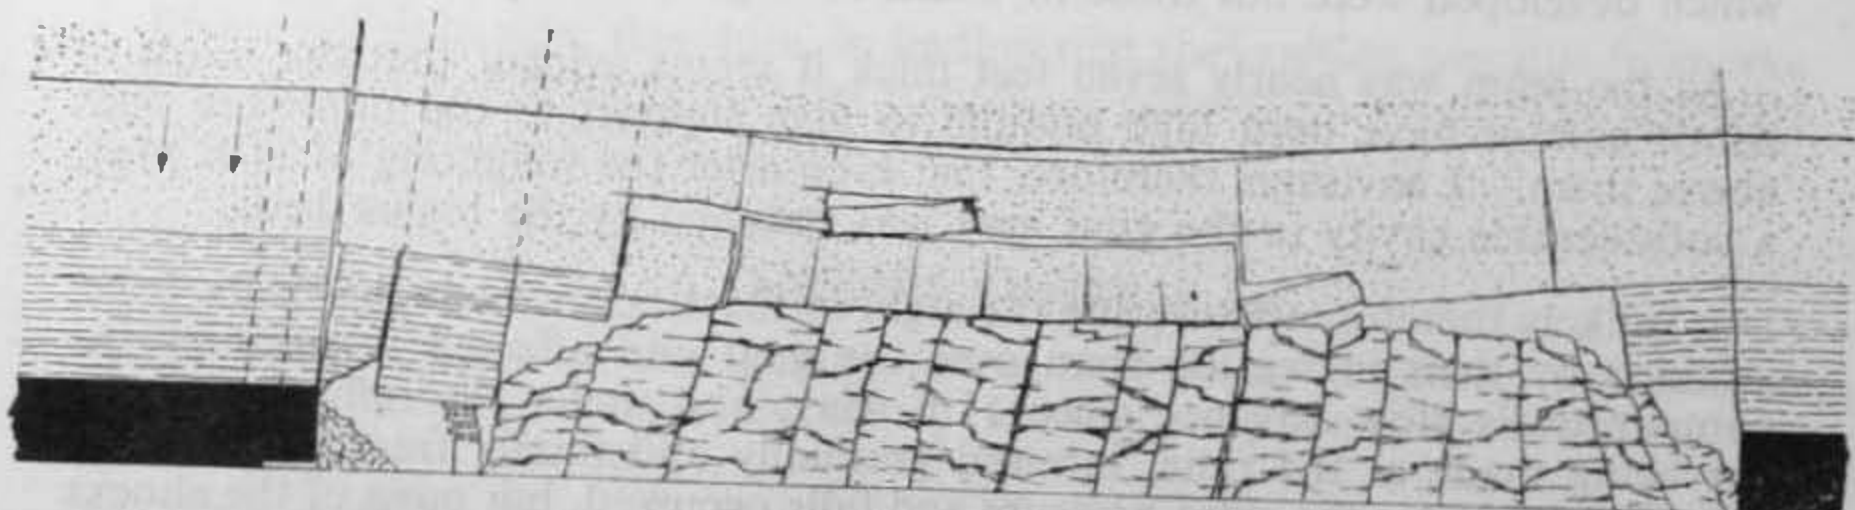
DIAGRAM I.

Considering the reasons for the occurrence of this weight, it seems to me that as the face advanced, the roof over the waste, being without direct support, would be carried on abutments in the solid coal sides, in the coal left behind, and in the coal ahead of the face. With the continuing advance the span over the goaf and consequently the abutment pressures would increase and some roof beds would lower and fracture. An attempt to show the trend of these occurrences, though not the actual happenings, is made in Diagram 1.

It is likely therefore that during the night of the disaster the higher beds, overstrained by their increasing span over the goaf and affected perhaps by the comparatively slow advance since 11th May, and under the influence of the cut being made at the time, lowered gradually and finally fractured. Many props broke under the extra pressure and falls occurred, but most of the chocks remained effective and limited the extent of the falls. That the weight continued after the explosion is shown by the fact that some of the surfaces of the chock blocks exposed by fracturing were not coated with dust.

ORIGINAL HEADING

AFTER FIRST ROOF FALL IN WASTE

AFTER ROOF FALL ON MAY 11TH

CONDITION ON AFTERNOON OF MAY 28TH.

CONDITION AFTER WEIGHT

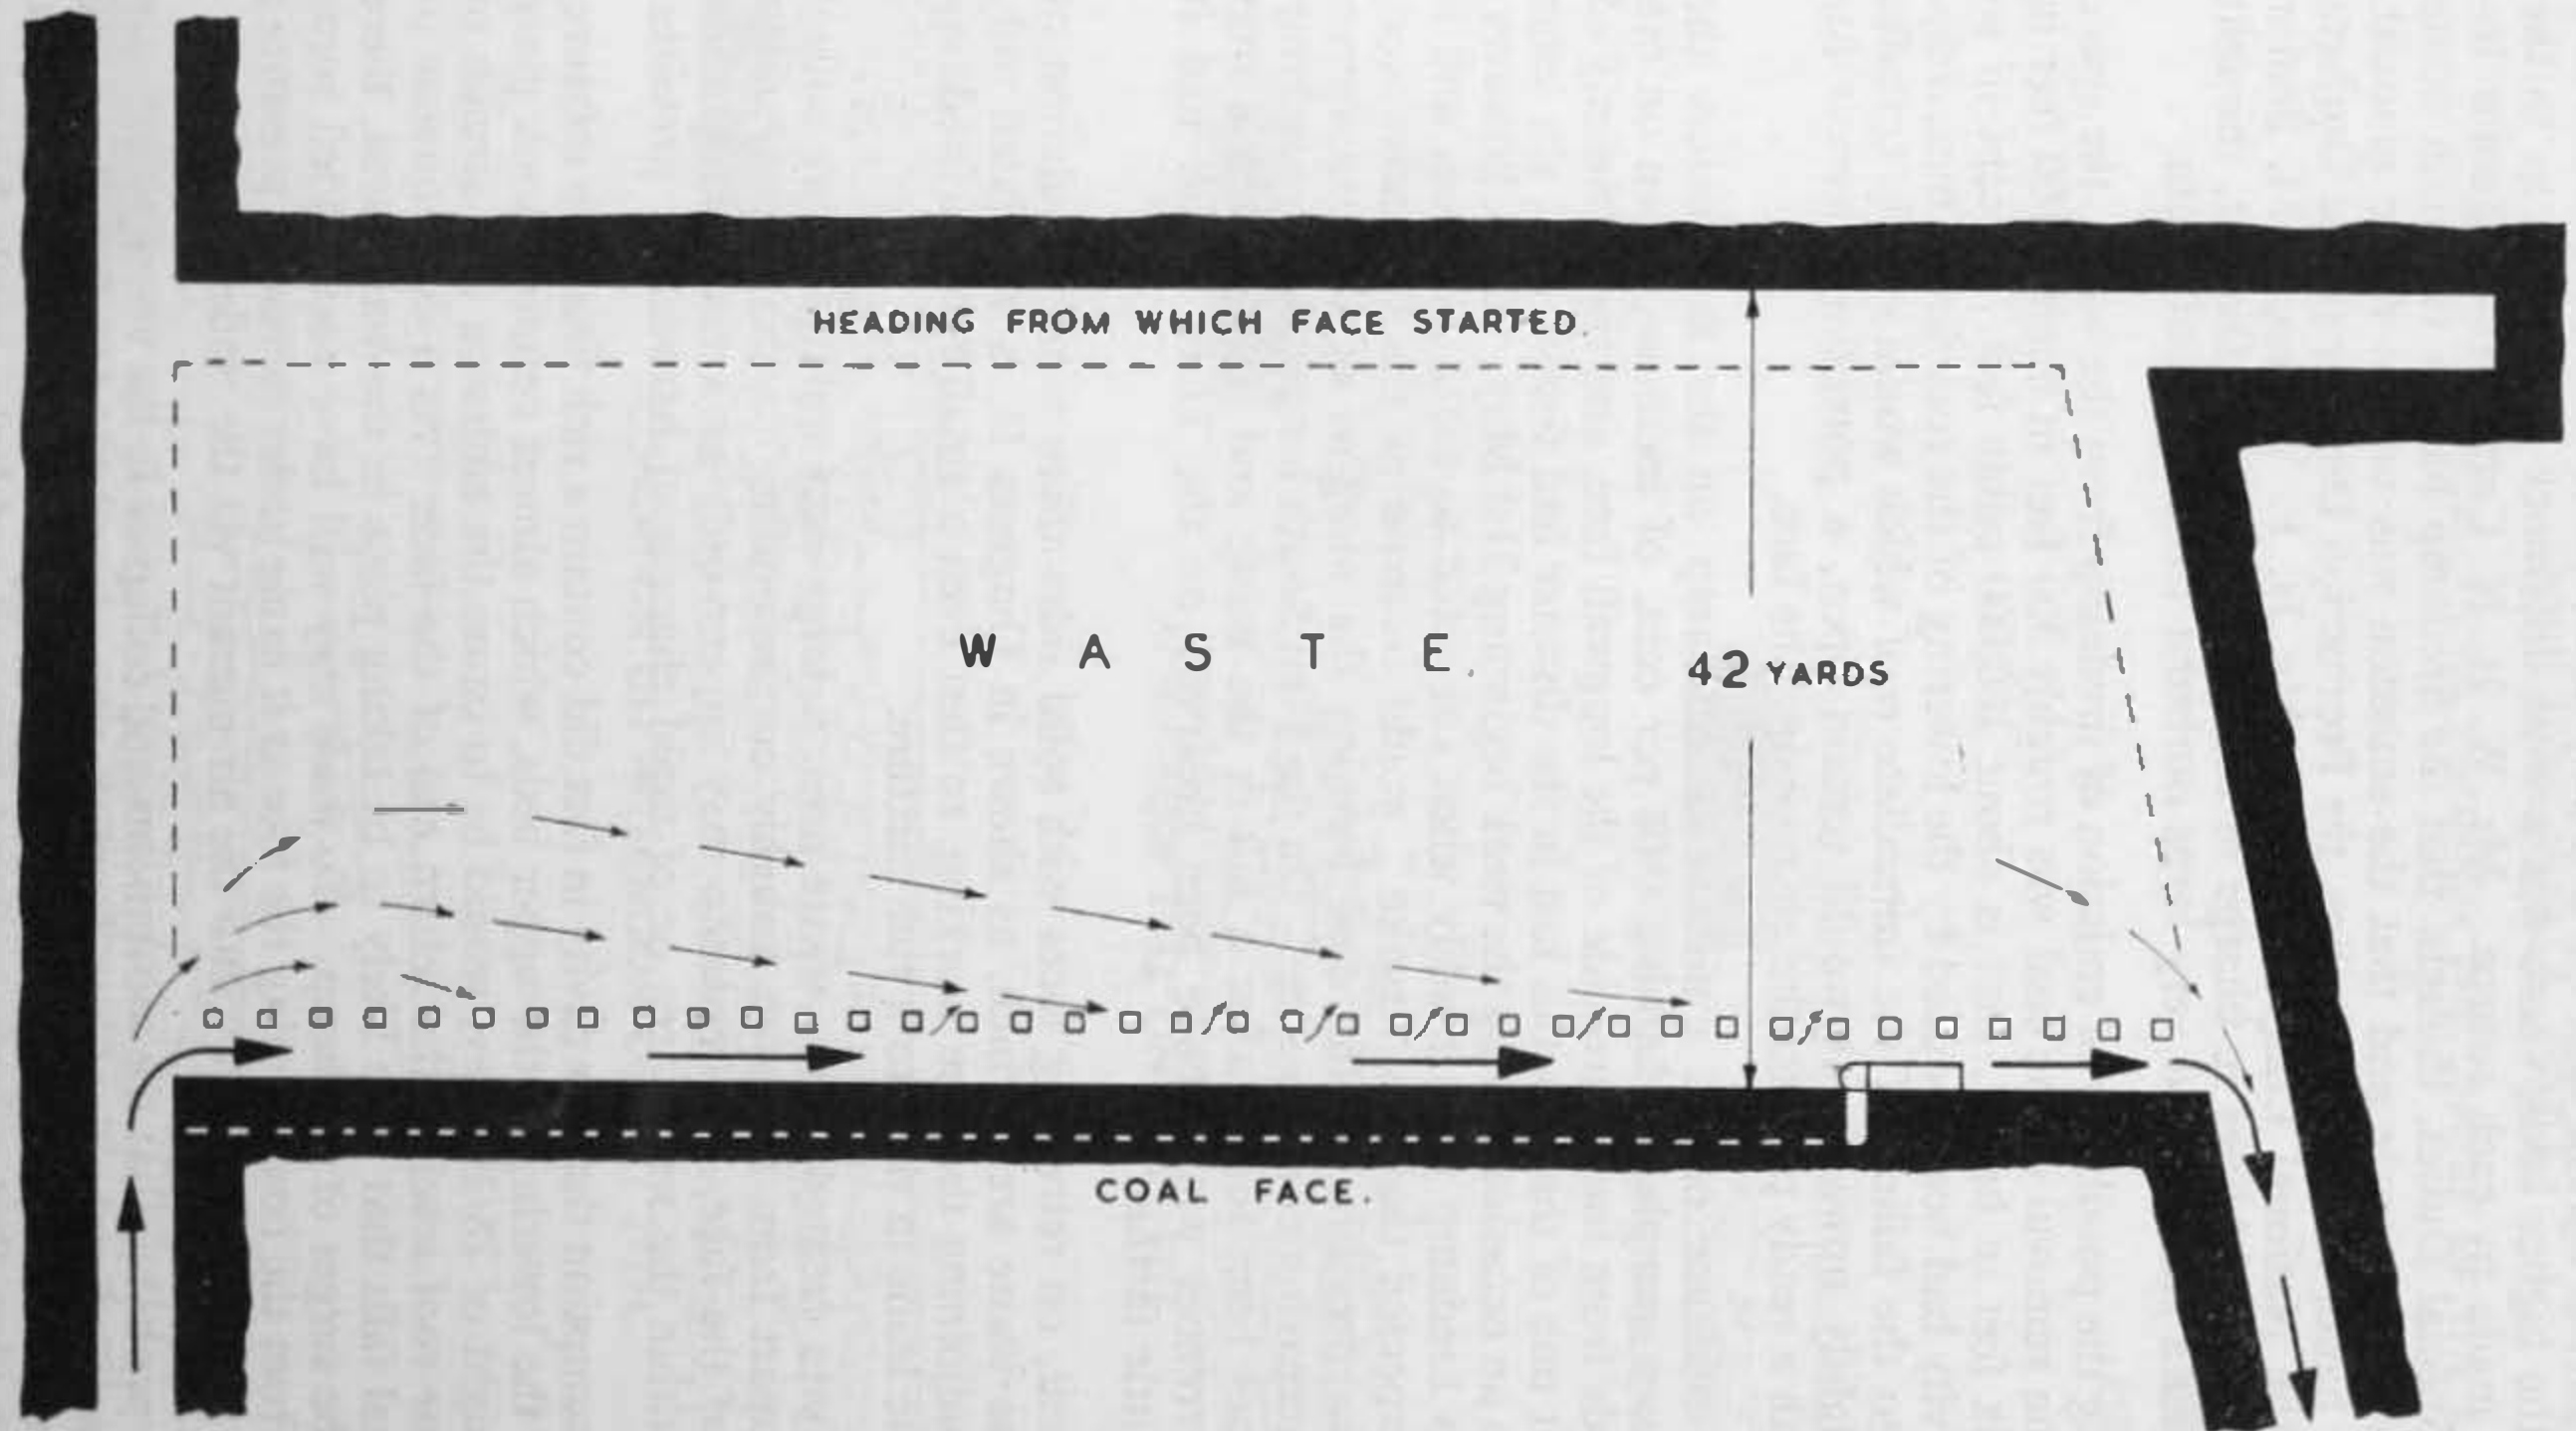
DIAGRAM II.

ILLUSTRATING PROBABLE CONDITION OF
VENTILATION OF LONGWALL FACE AND WASTE AREA

As a consequence of the incompleteness of the caving, considerable cavities must have existed in the goaf area. Because the face was retreating and had solid sides, there was not the ventilating pressure difference across the waste which, with leakage through the packs into the return, leads to the gradual release of firedamp from the waste of an advancing face. The emission of firedamp, although it was by no means rapid, would thus gradually fill the cavities to the point of overflowing, and the effect of the ventilating current would be, as shown in Diagram II, to conceal its existence.
